ARMY RESEARCH LABORATORY

Metallurgical Examination of M61A1 Breech Bolt Assembly Components

ARL-TR-684

February 1995

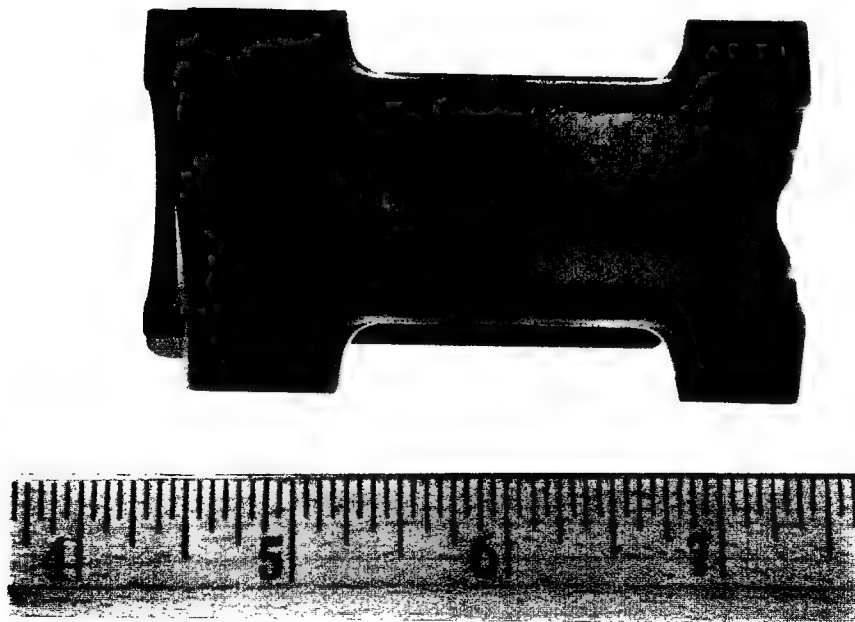
FIGURE 2 Top view of the as-received breech bolt assembly. Mag. 1x.

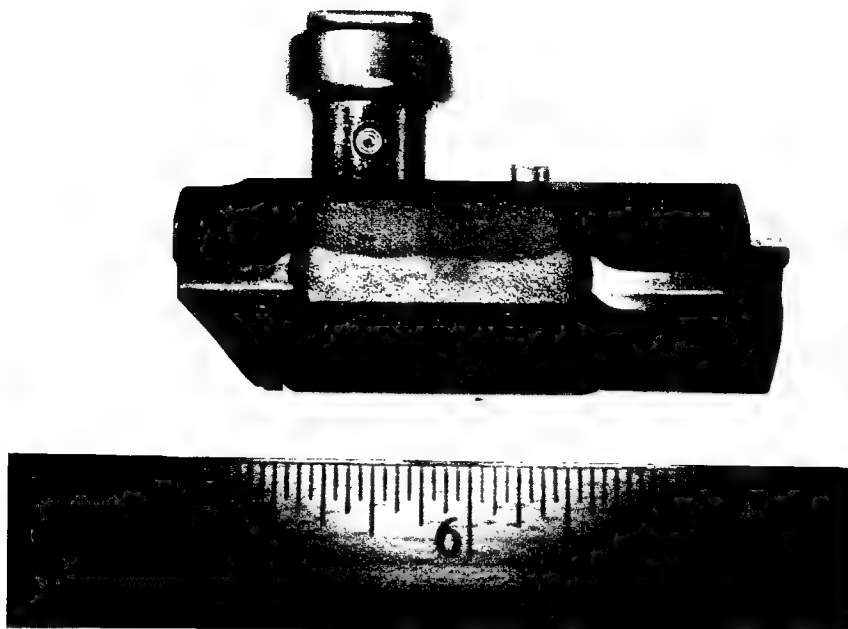
FIGURE 3 Side view of the as-received breech bolt assembly. Mag. 1x.

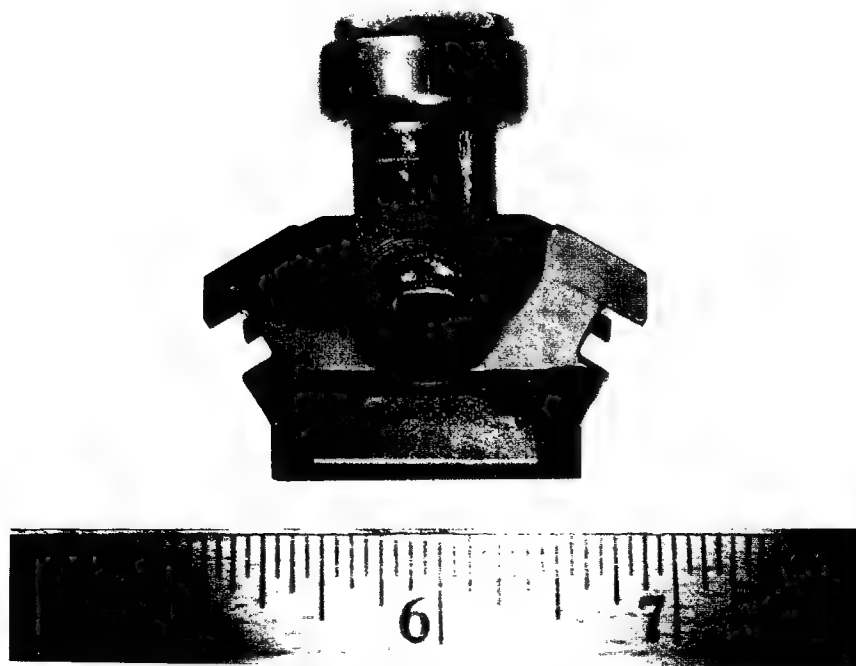
FIGURE 4 End view of the as-received breech bolt assembly. Mag. 1x.

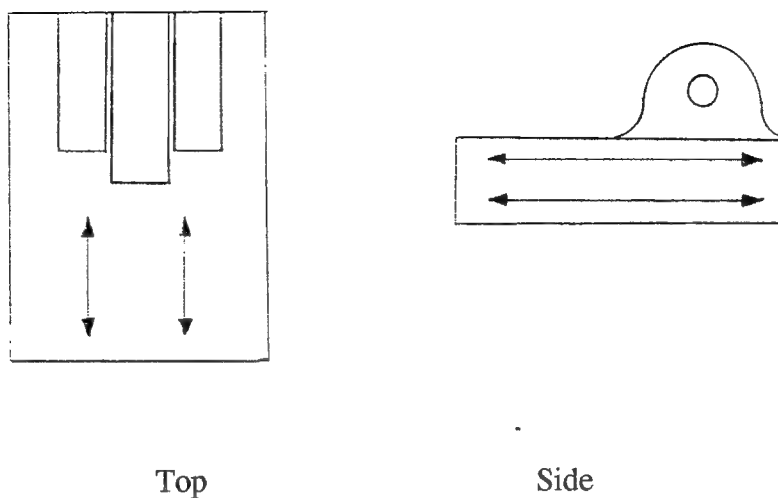
FIGURE 9 A schematic showing directions of surface finish measurement on the individual locking block.

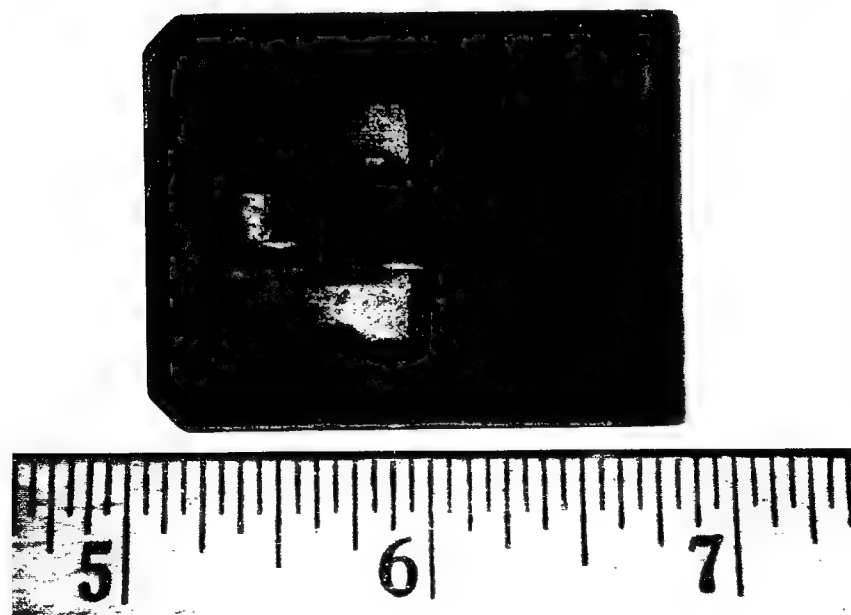
FIGURE 10 Top view of the individual locking block showing excessive machine marks. Surface finish was determined to be out of specification. Mag. 1.5x.

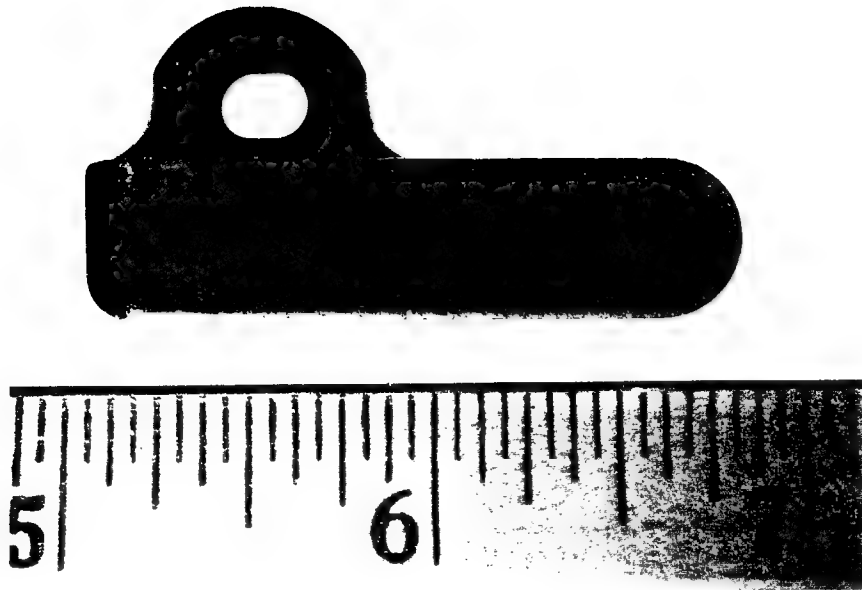
FIGURE 11 Side view of the individual locking block showing excessive machine marks. Surface finish was determined to be out of specification. Mag. 1.5x.

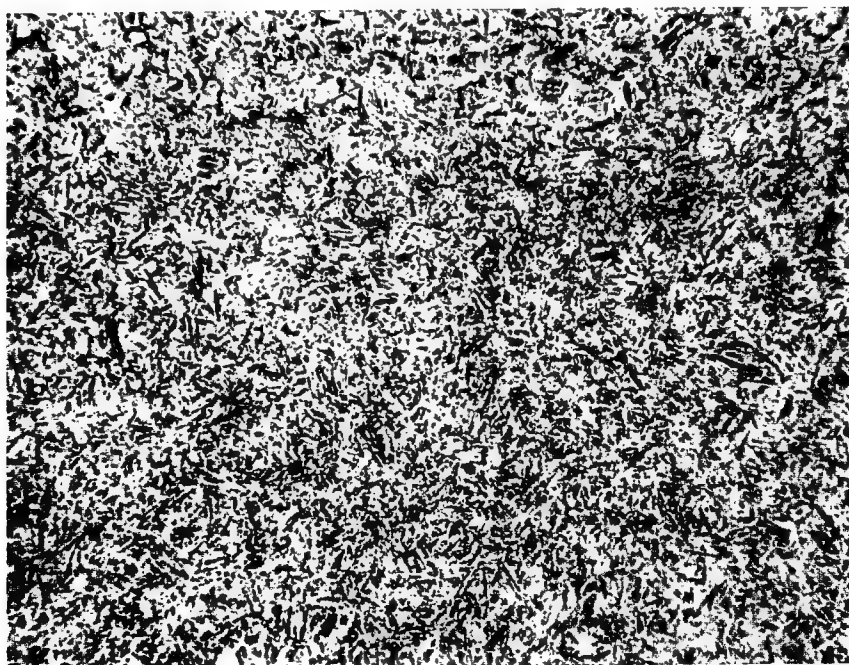
The sectioned portion of the locking block which was macroetched to verify grain flow, was also utilized to examine the microstructure of the material. A 4% nital etchant was applied to the polished surface, to reveal the fine tempered martensitic structure shown in Figure 14. This microstructure is consistent with the prior heat treatment (austenitize, quench and temper). Section 3.5 of MIL-F-7190 states that, *"the structure of the part shall be essentially uniform and free from defects."* The microstructure displayed no inherent material defects, and the material conformed to this requirement. However, noted around the periphery of the component was a layer of decarburization. Figure 15 shows a representative region of this decarburization. Note the distinct ferritic decarburized layer, the transition zone of ferrite and lower-carbon martensite, and the normal matrix of tempered martensite. Section 3.3.3.1 of MIL-H-6875 states that,

FIGURE 14 Individual locking block microstructure (AISI 4140) consisting of fine tempered martensite, typical of prior heat treatment. 4% nital. Mag. 300x.

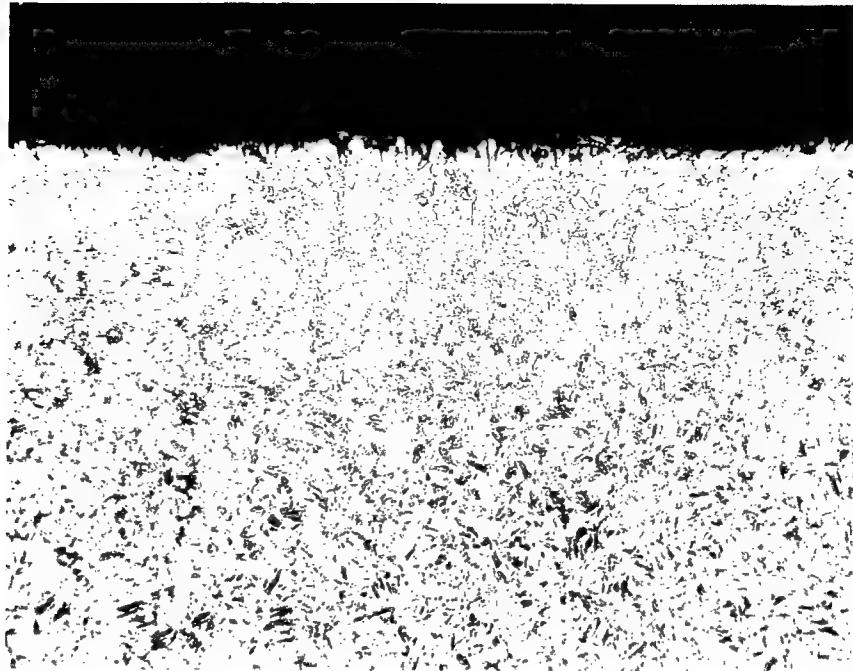
FIGURE 15 A decarburized layer found around the periphery of the individual locking block microstructure. Note the soft, blocky ferrite grains at the surface of the component. 4% nital. Mag. 250x.

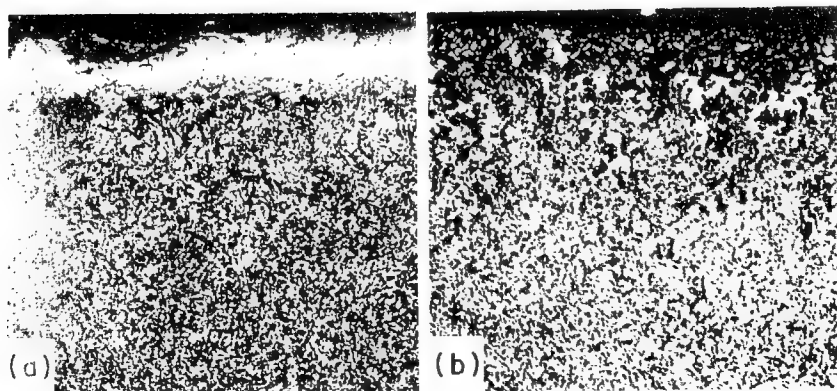
FIGURE 16 A "total" (a) and "partial" (b) decarburized layer of a hardened steel, utilized for reference. The decarburized layer found around the periphery of the individual locking block compared favorably to that of a total, or complete decarburized layer (Compare to Figure 15).

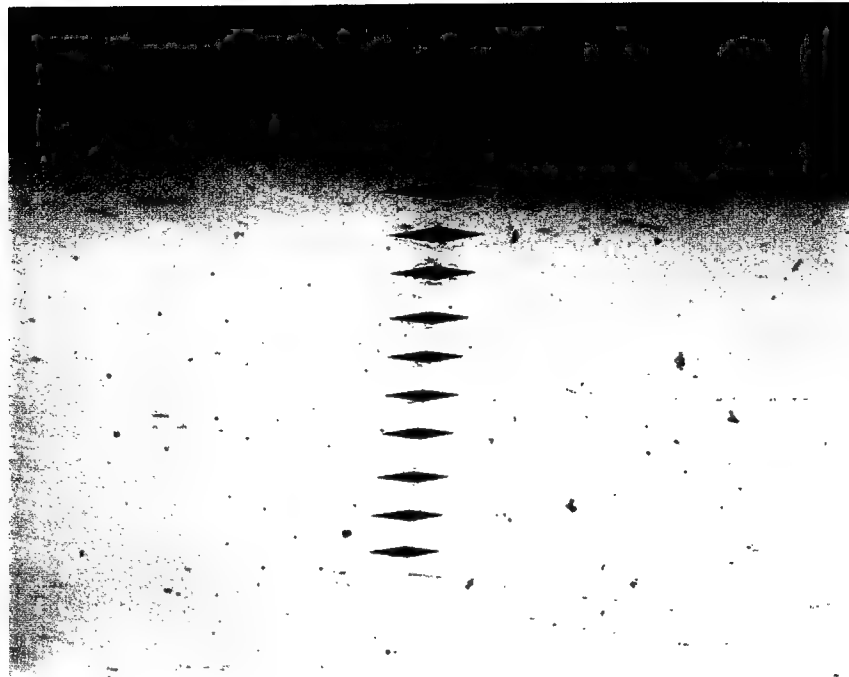
FIGURE 17 One of four Knoop microhardness profiles (Profile A) taken through the decarburized layer found around the periphery of the individual locking block. Note the larger indents (softer material) nearer the exterior of the component. As-polished. Mag. 200x.

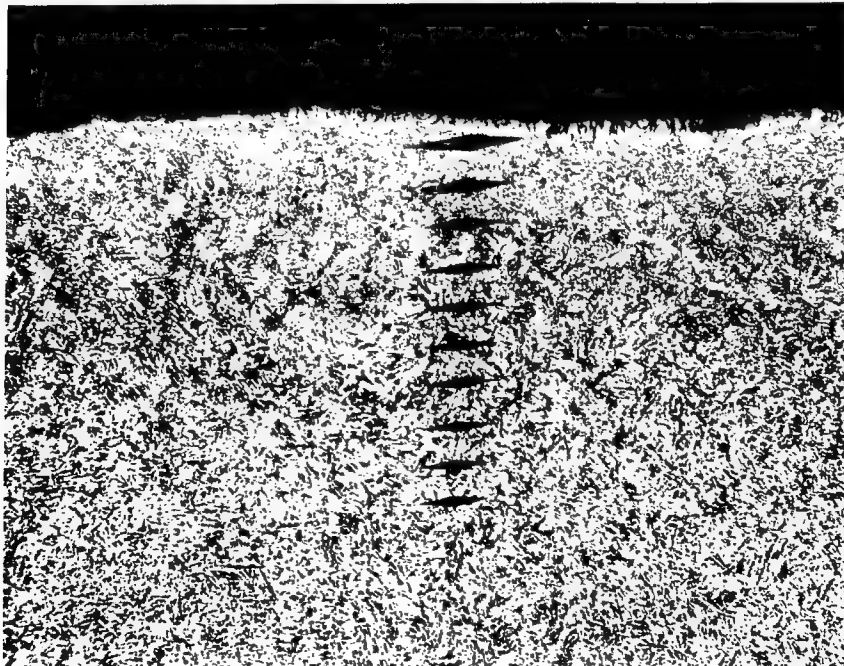
FIGURE 18 The Knoop microhardness profile shown in Figure 17 after application of an etchant. 4% nital. Mag. 200x.

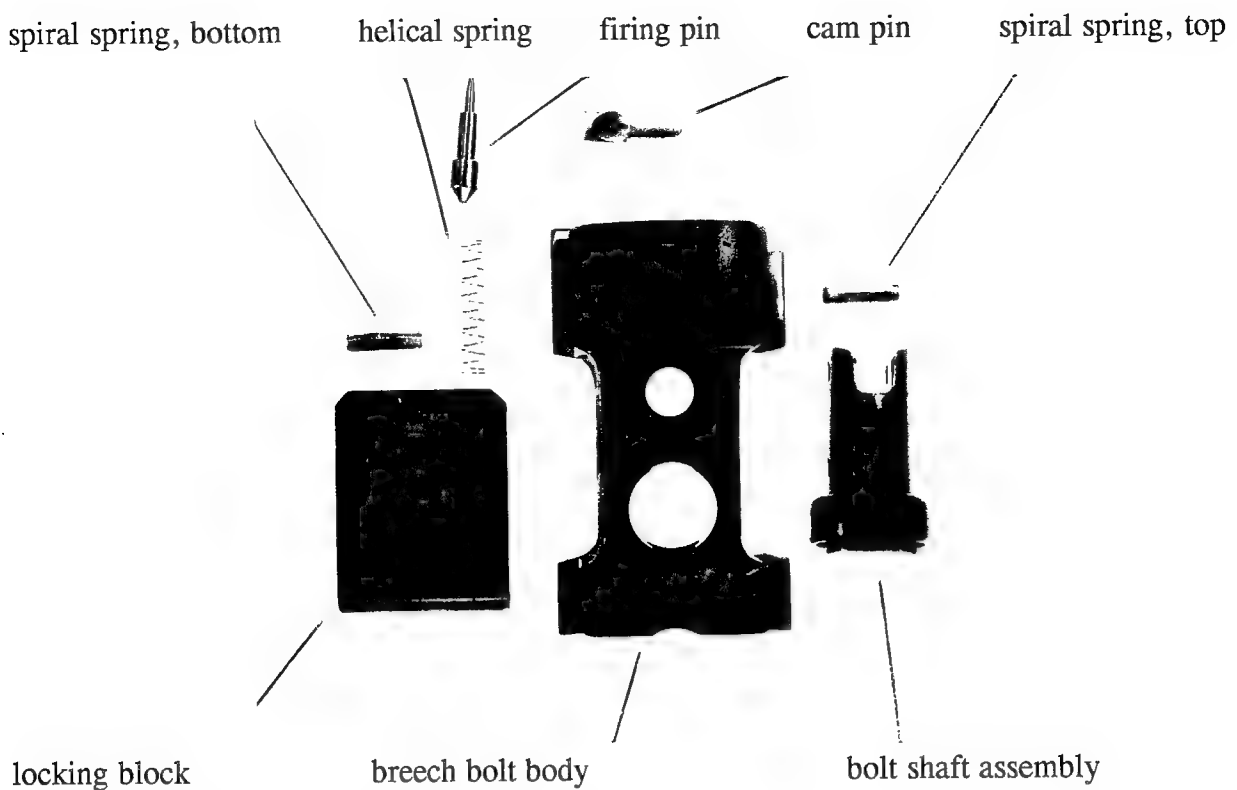
FIGURE 19 Macrograph of the disassembled breech bolt assembly. Reduced 50%.

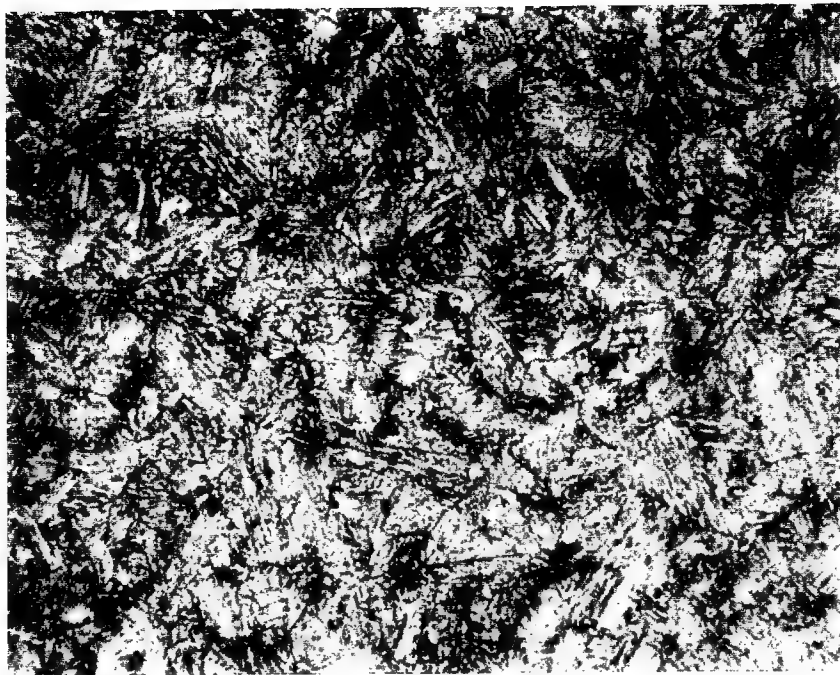
The sectioned and mounted portion of the firing pin was subsequently etched with 4% nital, in order to reveal the microstructure. The structure consisted of aged low-carbon martensite, as shown in Figure 23. This structure was consistent with the prior heat treatment (solution-anneal, age, air cool). Section 3.6.3 of MIL-S-46850 states that for Grade 300, Type III material, *the grain size shall be predominantly six or finer with grains as large as four permissible in accordance with the applicable ASTM E 112 chart*. The 100x micrograph of Figure 24 shows the grain size to be between seven and eight, in conformance to the governing specification. No internal or surface defects were noted within the microstructure.

FIGURE 23 Firing pin microstructure (Maraging, Grade 300) consisting of low carbon martensite, consistent with prior heat treatment. Fry's reagent. Mag. 300x.

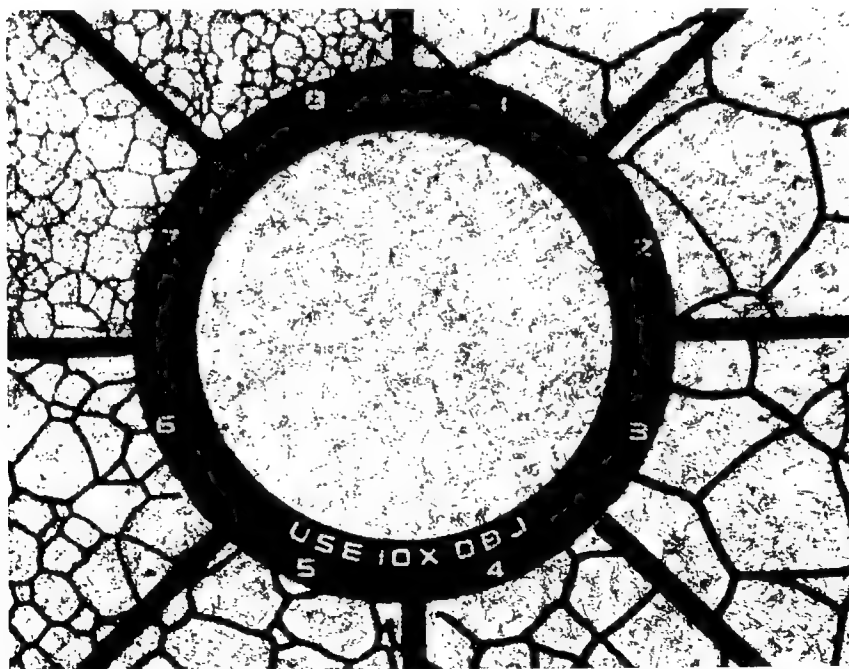
FIGURE 24 Grain size of the firing pin. Spec. MIL-S-46850 requires a grain size of six or finer (four is permissible). From micrograph, grain size is between six and seven. Fry's reagent. Mag. 100x.

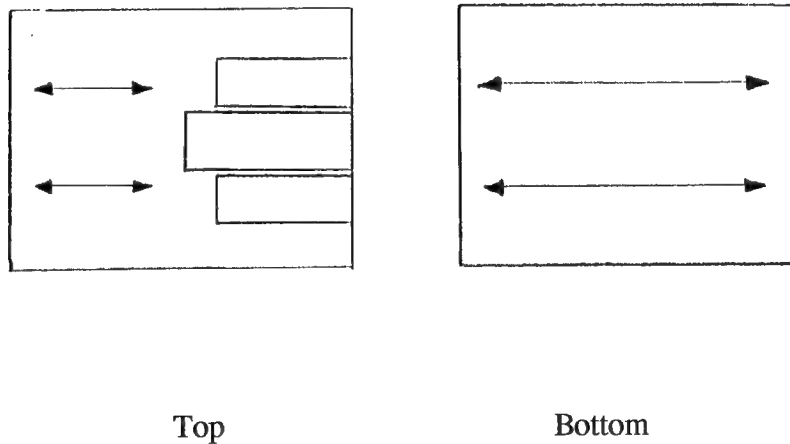
The surface roughness of the locking block was measured with the Mitutoyo Surftest 401 Analyzer. Readings were taken across the top and bottom of the part (see schematic in Figure 32). These were the regions of the component which exhibited machining marks, although not as severe as the machining marks noted on the locking block shipped separately (Figures 33 and 34). The required average surface roughness of the top and bottom of this component was 125 μ in RMS (Eng. Dwg. 11691480). The top surface registered an average of 58.4 μ in

FIGURE 32 A schematic showing directions of surface finish measurement on the locking block.

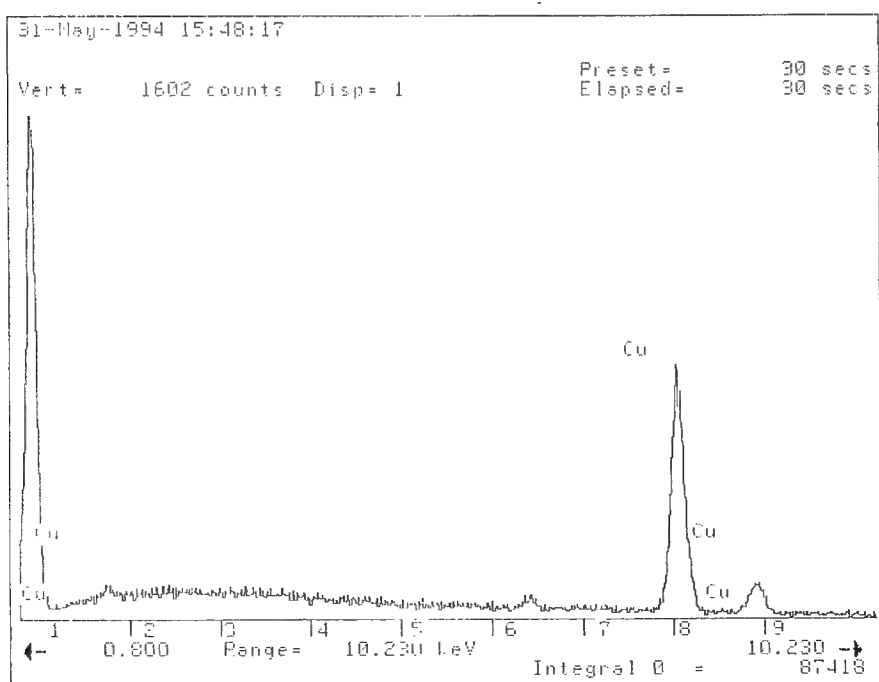
EDS of the coating on the "Top" spring, confirmed that copper plating was utilized. The iron peak represents the base metal, while the silicon and cobalt peaks represent elements found within the chemistry of the base material. EDS of the coating of the "Bottom" spring also confirmed the presence of copper plating, as shown in Figure 42.

FIGURE 42 Representative EDS spectrum of the plating on the spiral spring pins, verifying that copper was utilized, as represented by the copper peaks.

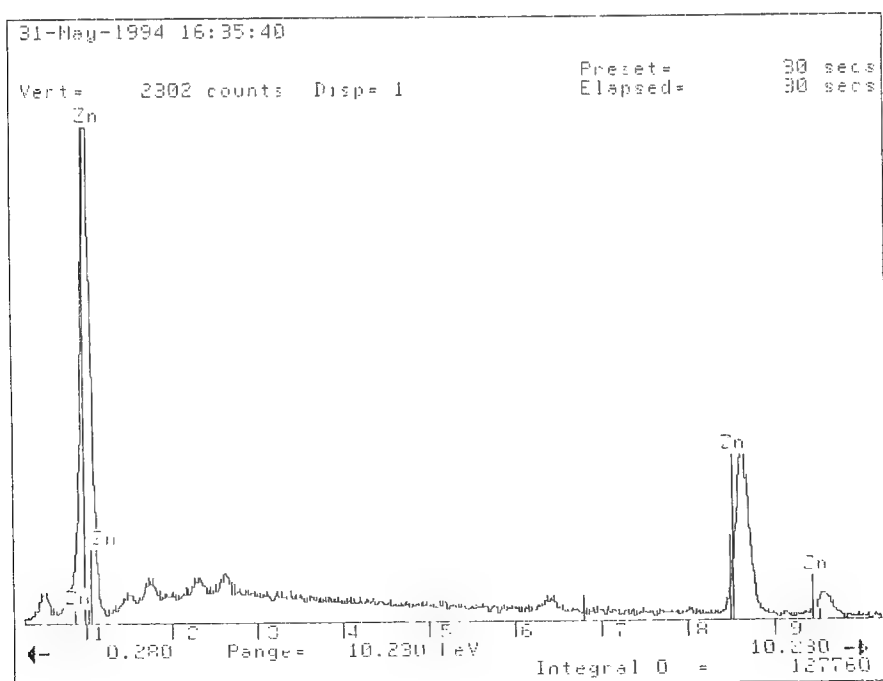
FIGURE 44 EDS spectrum of the plating on the helical compression spring verifying that zinc was utilized instead of cadmium, as represented by the zinc peaks.

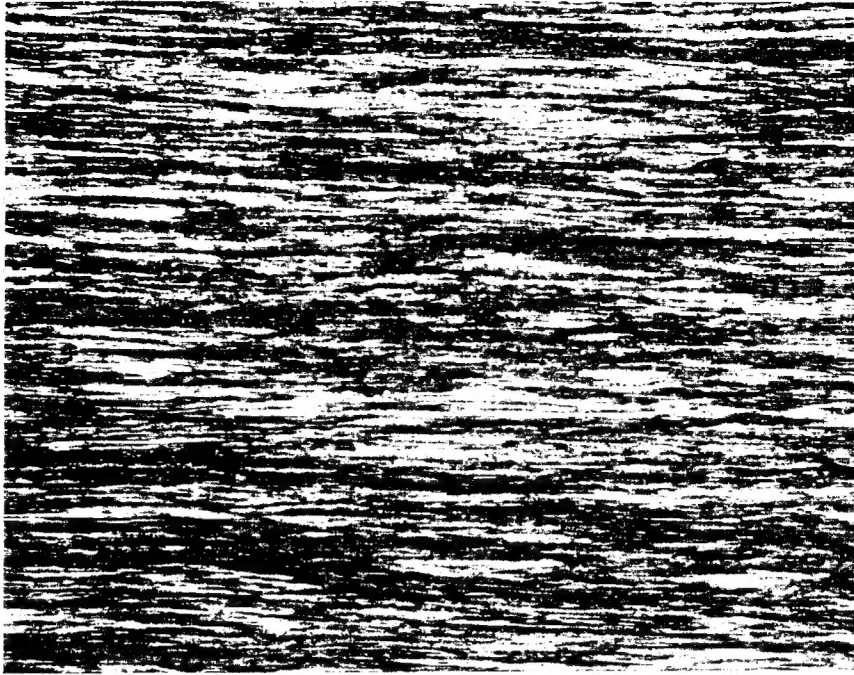
FIGURE 45 Helical compression spring microstructure consisting of elongated ferrite and fine pearlite grains, typical of a cold drawn, high carbon steel wire. 4% nital. Mag. 400x.
